Human Factors Evaluation of the High Mobility Artillery Rocket System (HIMARS) in the Combined HIMARS-Guided Multiple Launch Rocket System (GMLRS) Initial Operational Test

ARL-TR-4112 May 2007

Charles L. Hernandez Human Research & Engineering Directorate, ARL

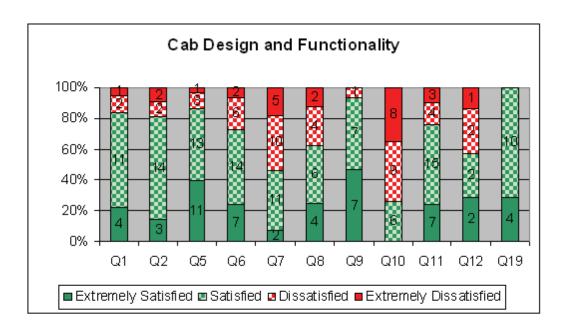
The questions that are categorized and grouped under "Cab Design and Functionality" are shown in figure 1. The HIMARS launcher (consisting of an FCS, a carrier [automotive portion], and a launcher module) is mounted on a FMTV 6x6 all-wheel-drive 5-ton truck. The FMTV crew cab is modified so that a crew of three can employ the HIMARS to meet operational requirements. Crew cab modifications also provide for crew survivability and safety and protect the crew from toxic gases, tube cover impact, and launch area debris penetration during firing activities. A CAFU in the cab forces outside air through an M48 filter, causing an over-pressure condition, which also prevents gasses from entering around doors or other small openings. Finally, the cab interior has been modified so that the FCS, communications equipment, and controls and indicators required to operate the HIMARS launcher are adequately housed. Overall, the HIMARS and RSV/T crews were satisfied with cab design and functionality; 70% of all responses for the 11 cab-related questions were either a "1" (extremely satisfied) or a "2" (satisfied). HIMARS crews specifically expressed no less than 50% satisfaction in all questions except for question 10 (steering wheel design). For this question, all HIMARS crews expressed dissatisfaction.

While the crews were overwhelmingly satisfied that the cab adequately protected them from launch hazards, debris, tube covers, plume pressures and from the flash of rocket firings (Question 9), a high percentage of respondents (54%) were dissatisfied with the design and function of the cab doors and windows (Question 7). In addition, many (37%) were not satisfied that exhaust fumes from rocket and missile firings entered the cab and affected the crew (Question 8).

- A large percentage of crew members (74%) expressed dissatisfaction with the design of the steering wheel in the cab (Question 10). Almost half of the dissatisfied crew members expressed "extreme dissatisfaction" which qualified it as the single design issue to receive the highest rating of "extreme dissatisfaction". The fact that this is a design issue is not new, since it surfaced in other developmental and integrating testing.
- One third of the HIMARS section chiefs were dissatisfied with their seating position in the HIMARS cab (Question 12). An ammunition platoon sergeant expressed extreme dissatisfaction with this position.

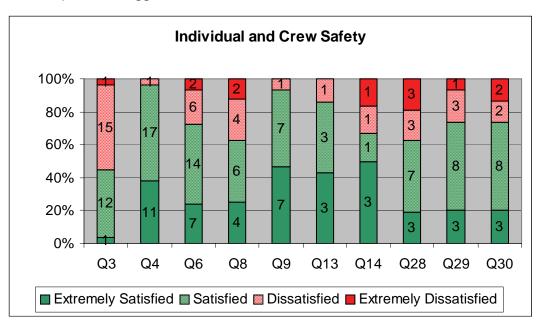
Figure 2. Satisfaction/dissatisfaction: individual and crew safety.

The questions that are categorized and grouped under "Individual and Crew Safety" are shown in figure 2. They include questions 6, 8, and 9 cross walked from "Cab Design and Functionality" and discussed before. The questions address a variety of safety features and considerations for both the HIMARS and the RSV/T.

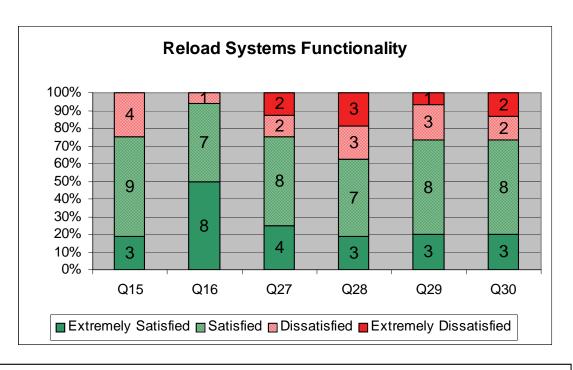
The questions that are categorized and grouped under "Reload Systems Functionality" are shown in figure 3. They include questions 28, 29, and 30 cross walked from "Individual and Crew Safety" and discussed previously.

Overall, the crews were satisfied with the functionality of the reloading systems for both the HIMARS and RSV/T; 76% of all responses were either a "1" (extremely satisfied) or a "2" (satisfied). Questions 15 and 16 pertain to the HIMARS launcher and for these, 88% of the HIMARS crews' responses (21 of 24) were "satisfaction" responses. Questions 27 through 30 pertain to the RSV/T and for these, only 59% of the RSV crews' responses (26 of 44) were "satisfaction" responses. These questions also cross walk to the "Individual and Crew Safety" category with some interesting focused feedback that suggests the need for engineering improvements in the MHC.

- Regarding the RCU, although not specifically cited as such, the seven responses that addressed an unstable slew of the crane may also suggest an issue with the RCU. One Soldier cited that when he was operating the RCU, the crane hesitated at times during prolonged use (appendix A, Part III, Q4). Nine Soldiers' responses to Question 4 indicated that they had no problems with the RCU; it worked fine and was a good item. Two Soldiers identified that the crane is inherently unsafe with its uncommanded movements, and jerky movements that affect the load being raised or lowered (appendix A, Part III, Q7). Finally, many referenced concerns with the crane hydraulic lines not being protected.

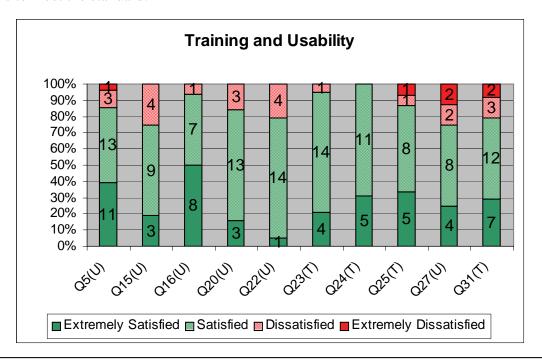
Figure 4. Satisfaction/dissatisfaction: training and usability.

Figure 4 shows the questions that can be categorized and grouped under "Training and Usability". They include question 5 cross walked to "Cab Design and Functionality" and questions 15, 16, and 27, which can be cross walked to "Reload Systems Functionality". Overall, HIMARS and RSV/T crews were satisfied with the training they received and the ease of using the selected capabilities mentioned in the questions. Of all responses made for the 10 related questions, 85% were either a "1" (extremely satisfied) or a "2" (satisfied). Overall, satisfaction was the second highest rated of all the functional categories. This is further supported by the training assessments the Soldiers provided for themselves in Part II of the survey. All 12 HIMARS operators assessed that they fully understood how to perform their required tasks. Six of the 12 (50%) recorded that they could

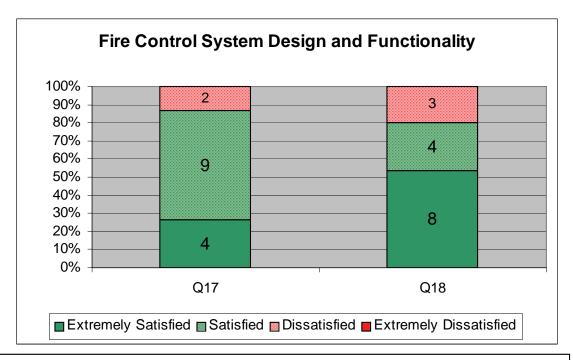
Figure 5. Satisfaction/dissatisfaction: FCS design and functionality.

Figure 5 shows the questions that can be categorized and grouped under "Fire Control System Design and Functionality". The overall quantities of satisfaction ratings were high; 83% of all the responses were either a "1" (extremely satisfied) or a "2" (satisfied). Of the dissatisfaction ratings, only two were from HIMARS operators. The other three were from support platoon personnel. Since it can be assumed that the support platoon personnel did not regularly use the HIMARS FCS, we can remove three of the five dissatisfaction ratings to achieve revised percentages. These percentages improve the overall satisfaction rating markedly, from 83% to 93%. This high satisfaction rating is further corroborated by the fact that the low cost fire control panel and its software functionality was one of the two HIMARS capabilities the Soldiers liked the most (appendix A, Part II, Question 1).

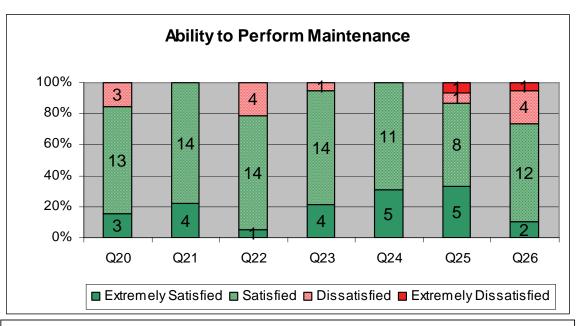
The questions that can be categorized and grouped under "Capability to Perform Maintenance" are shown in figure 6. Six of the 10 maintenance related questions also crosswalk to the "Training and Usability" category discussed earlier. Overall responses showed a high satisfaction rate; 88% of all the responses were either a "1" (extremely satisfied) or a "2" (satisfied) rating. The two highest dissatisfaction ratings were recorded for Question 22 (Ease of use of IETM) (21%), and Question 26 (organization and understandability of IETM tutorials) (26%).

- For question 22, 3 of 12 HIMARS operators and one support platoon Soldier rated that they
 were dissatisfied that the IETMs were not easy to use. Neither elaborated on their discontent
 nor made any recommendations to improve the IETMs in the focused feedback portion of the
 survey.
- For question 26, 4 of 12 HIMARS operators and the same support platoon Soldier rated that
 they were dissatisfied with the IETM tutorials. Again, neither provided any focused feedback to explain their dissatisfaction nor made a recommendation to improve the IETM
 tutorials.
- Four Soldiers indicated that more instruction on trouble-shooting procedures was needed while another wrote that he thought HIMARS launcher training should include more time dedicated to the IETM portion (appendix A, Part II, Question 9).
